INDOOR AIR QUALITY REASSESSMENT

**Massachusetts Department of Education
17 Pleasant Street
Malden, Massachusetts**

Prepared by:
Massachusetts Department of Public Health
Bureau of Environmental Health Assessment
August, 2001

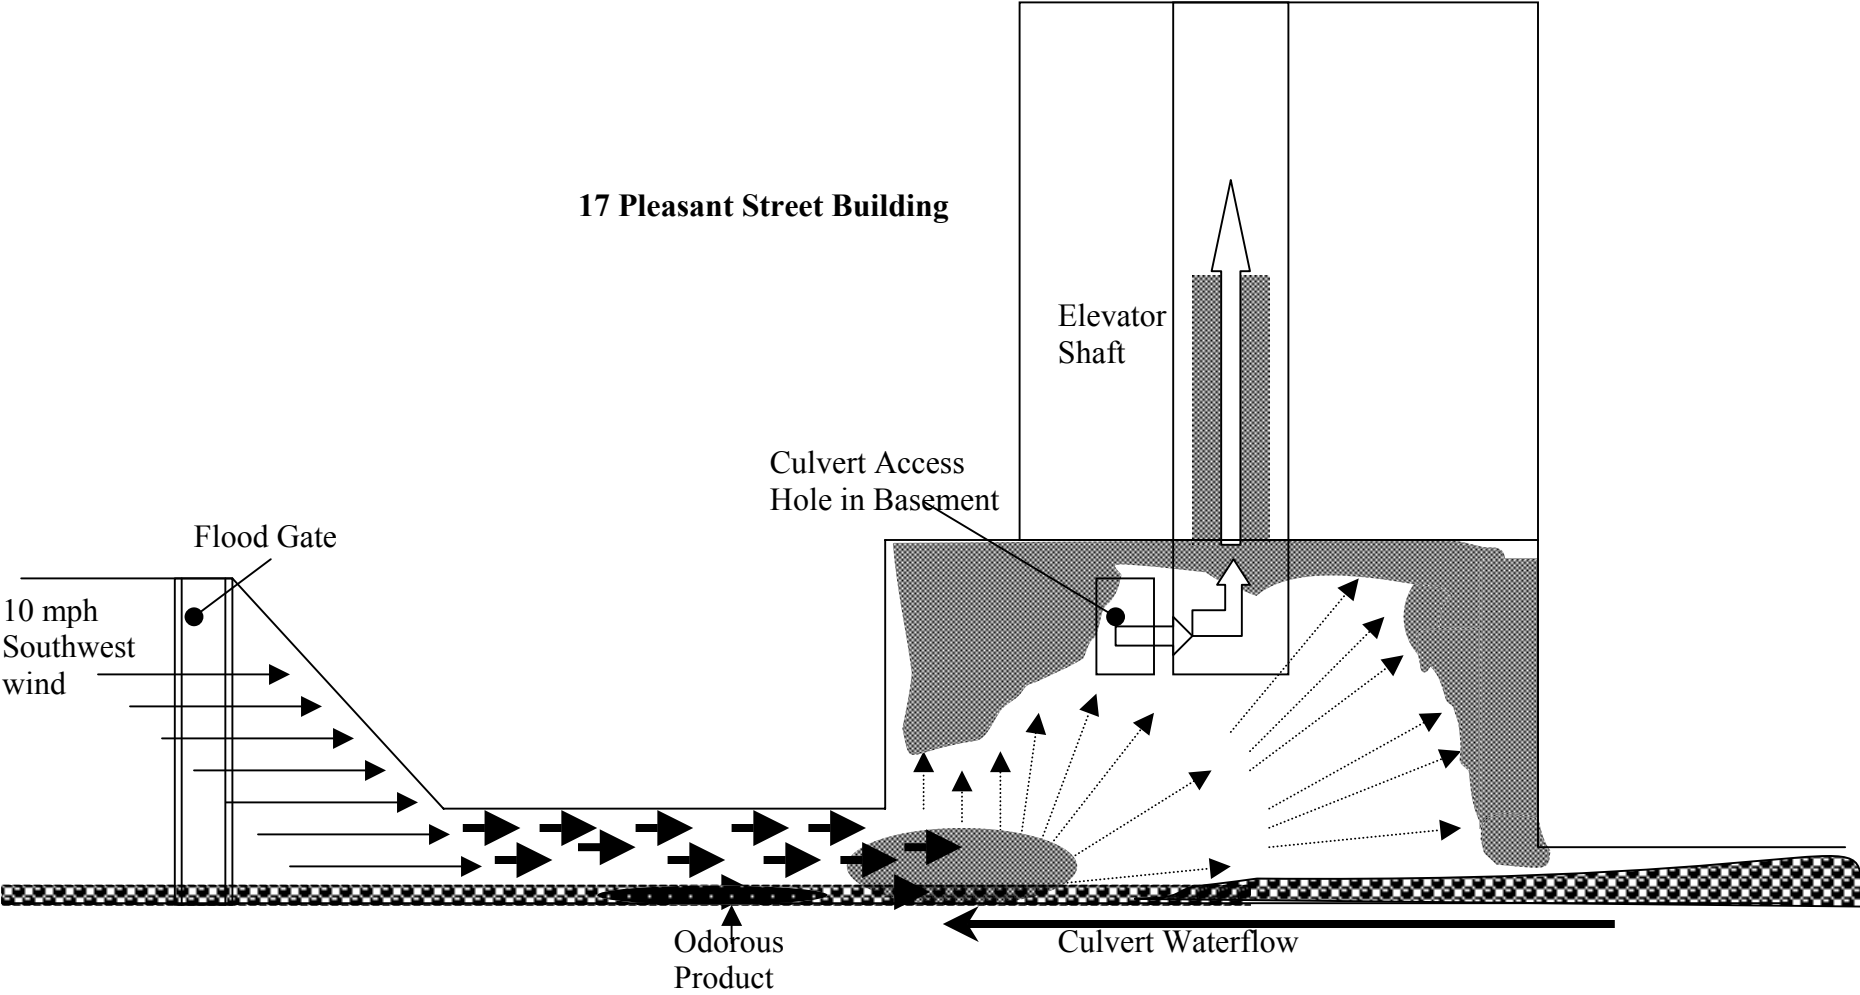
Figure 1 **Pressurization of Culvert Chamber Forcing Odors into 17 Pleasant Street**

The means for how this odor is moving, from its location by the Centre, Exchange and Jackson Streets area to a point two blocks upstream, is due to the location of the south culvert entrance, the size change in diameter of the culvert and the location of the culvert chamber below 17 Malden Street. The Malden River opening of the culvert faces south. Its configuration makes the culvert vulnerable to pressurization in a south, southwesterly wind. The culverts act as an air scoop, directing wind into the culvert interior. Malden Water and Sewer Department personnel report that the diameter of the culvert alternates in size along its course. The south opening in the culvert is an estimated twenty feet in height. The culvert reduces to a three foot diameter until it reaches the chamber beneath 17 Pleasant Street, where it expands to ~15 feet in height and ~30 feet in width. The width of the culvert again decreases in diameter to 3 feet. The configuration of the culvert chamber below 17 Pleasant Street serves as an air baffle

that slows the airflow. If airborne contaminants in the upwind section of the pipe are entrained, the airflow carries these contaminants into the chamber where the slowing of airflow and structure of the culvert chamber can create pooling of these materials (see Figure 1). The culvert chamber becomes pressurized by: 1) airflow into the chamber downstream and 2) water filling the culvert upstream, creates an air pocket and forces air back into the chamber. With the chamber pressurized, accumulated air and airborne contaminants will be forced from the chamber through cracks, crevices, spaces around plug/doors, and other openings that exist in the culvert chamber's walls, floor and ceiling.

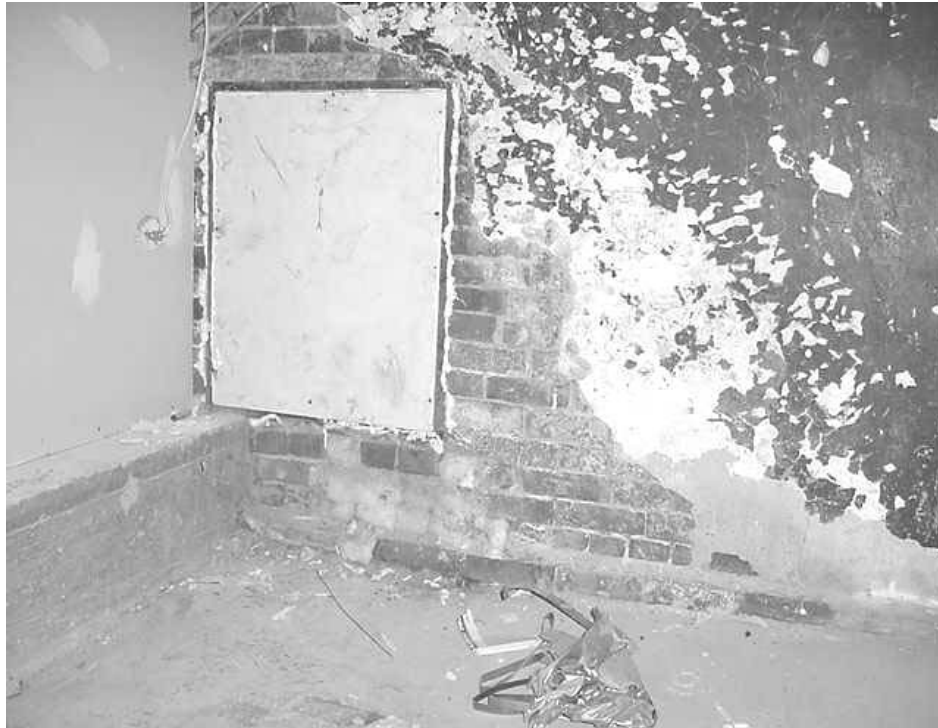
Picture 1

As previously mentioned BEHA's findings and recommendations regarding the reported odors are well detailed in previous BEHA correspondence (see Appendices A & B). Air monitoring results for TVOCs on March 27, 2001 were roughly double that of outdoor background concentrations (0.3 ppm) with the highest reading measured in the elevator foyer (0.8 ppm). Odors were detected in various sections of the building by BEHA staff, primarily around stairwell doors and the elevator (see Tables). TVOC measurements confirmed the presence of volatile organic compounds in the indoor environment, which were traced to a sealed opening in the east wall of the basement adjacent to the elevator shaft (see Picture 1). The plug on this opening was removed to

Sealed Opening in the Basement East Wall Adjacent to the Elevator Shaft

5. Examine the elevator well for air pathways from the culvert. These pathways must be sealed.
6. Seal the frame of the portal with a plug that is larger than the portal frame. Affix a caulking material in a continuous application so that when the plug is placed over the wood frame, an airtight seal is created.

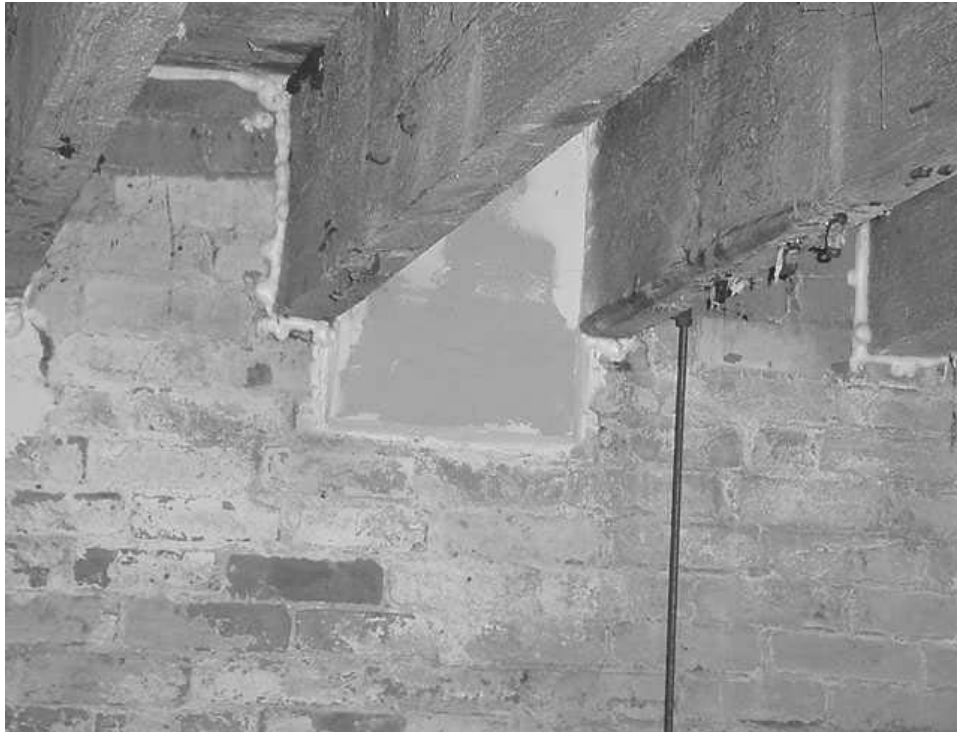
Picture 2

reveal the presence of a drainage culvert that shares the east wall of the building foundation (see Picture 2). Additional plugs, consisting of a gypsum wallboard (GW) type material, sealed similar openings into the culvert along the east basement wall (see Picture 3) on the opposite side of the elevator shaft. Installation of the elevator shaft removed the original ceiling of the culvert, which was replaced with corrugated steel decking (see Picture 4). Measurements of 1 ppm of TVOCs inside the culvert indicated that the source of odors was most likely inside the culvert. It should be noted that TVOCs have a relatively low odor threshold and for that reason their presence can frequently be detected below levels of health concern.

Holes In East Wall Sealed with Wallboard

7. Once the plug is installed, continue to seal holes/spaces in the east wall of the basement.
8. Install weather stripping and door sweeps on all stairwell doors and the basement door to create a barrier

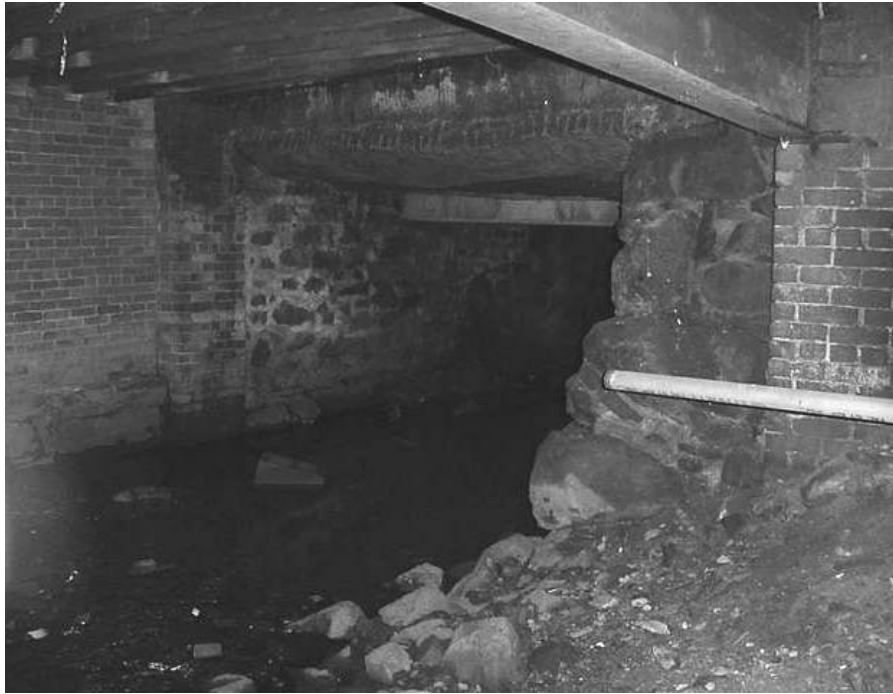
Picture 3

Drainage Culvert That Shares the East Wall of the Building Foundation

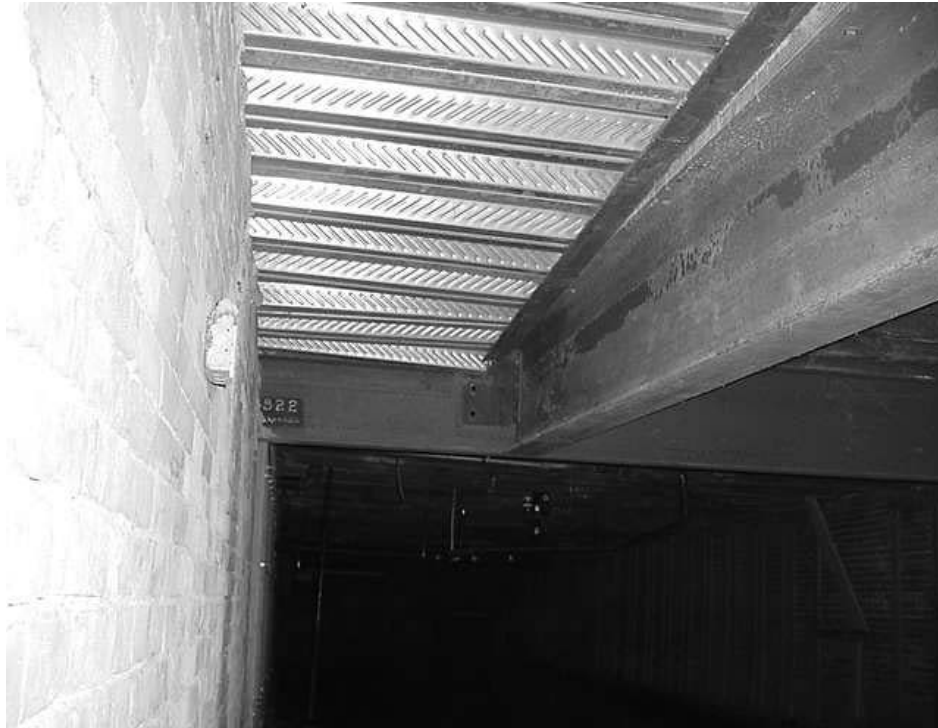
Picture 4

Original Culvert Ceiling Replaced With Corrugated Steel Decking

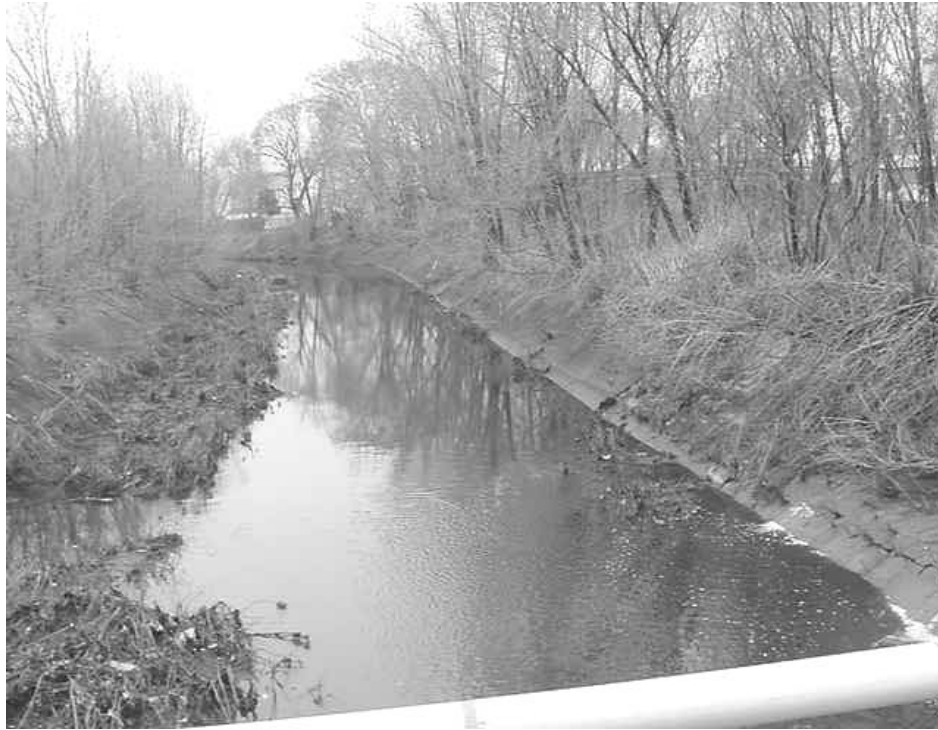
Picture 5

Concrete Lined Streambed

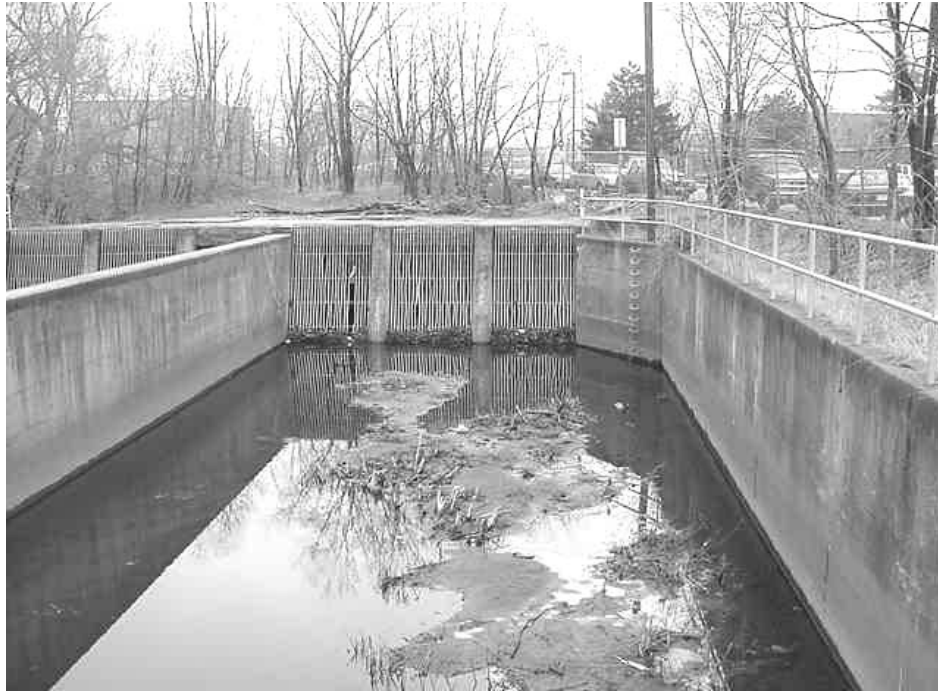
Picture 6

Culvert through Flood Control Gates Upstream Opening Near Forest Hills MBTA Station

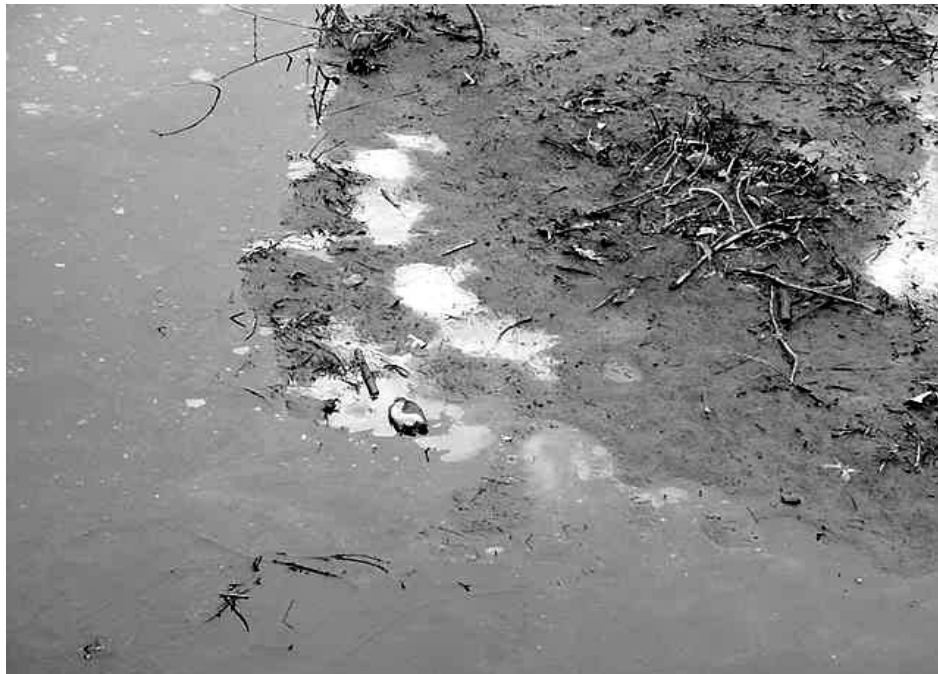
Picture 7

Sheen of an Unknown Product in the Forest Hills Flood Control Channel

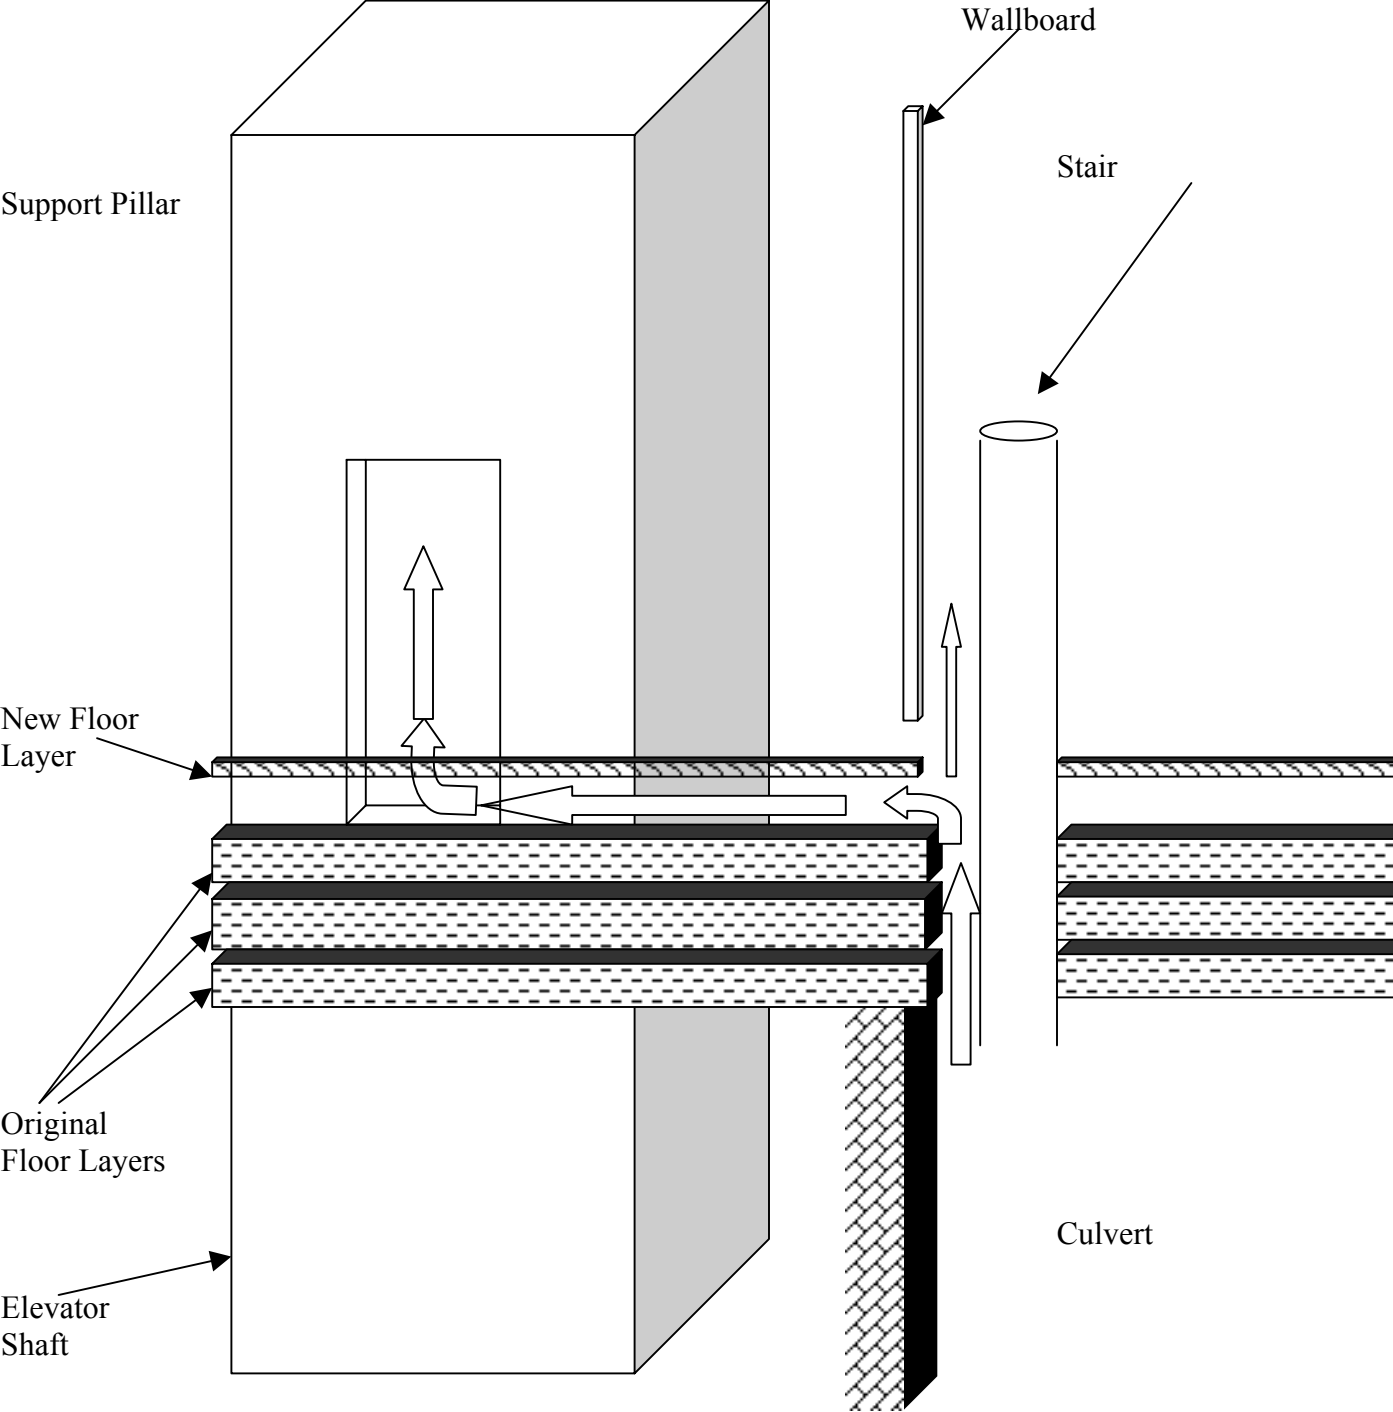
Figure 1 **Schematic of Pathway of Airflow from Culvert into the Elevator Shaft through Floor Layers**

During this assessment, Mr. Feeney located an opening in the wall that is sealed with a plug held in place with screws in the area of the basement below the first floor foyer. This plug seals a portal that opens into a culvert system, which appears to share the east wall of the basement. The origin of the odor appears to be outside of the building, emanating from the opening into the culvert system when the plug was removed. A similar odor was noted emanating from storm drains in front of the building and beneath the loading dock. A pathway (presumably somewhere along the basement east wall or ceiling decking over the culvert) exists that allows for the odor to be drawn from the

culvert into the building's elevator shaft. Once inside the shaft, the odor is distributed to upper floors through the elevator doors.

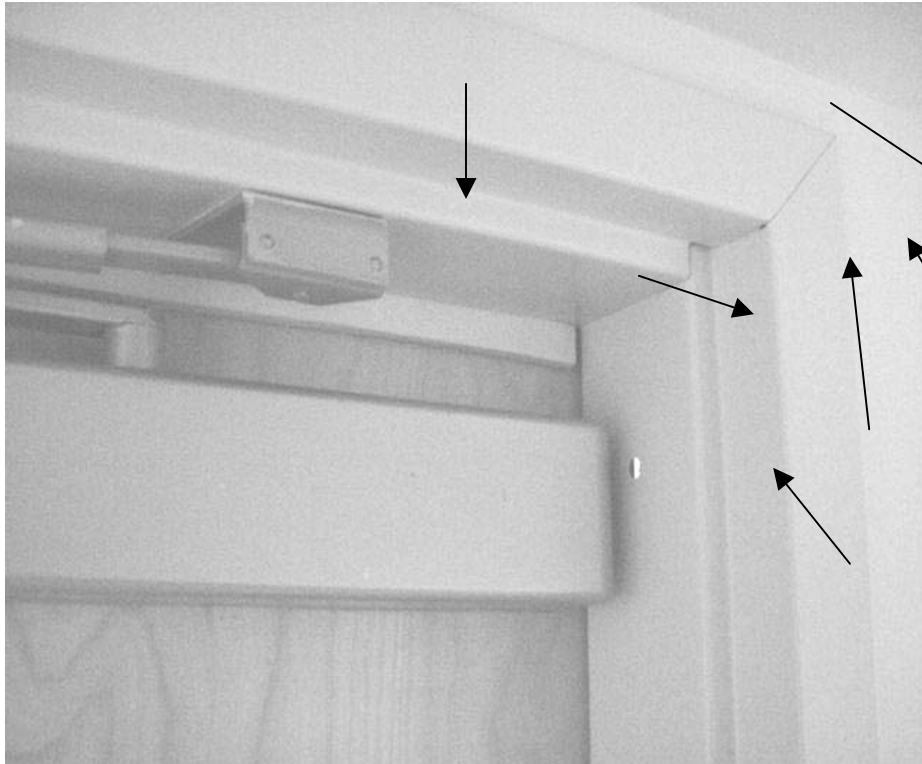
Picture 1

Arrows Indicate Seams That Need Be Rendered Airtight

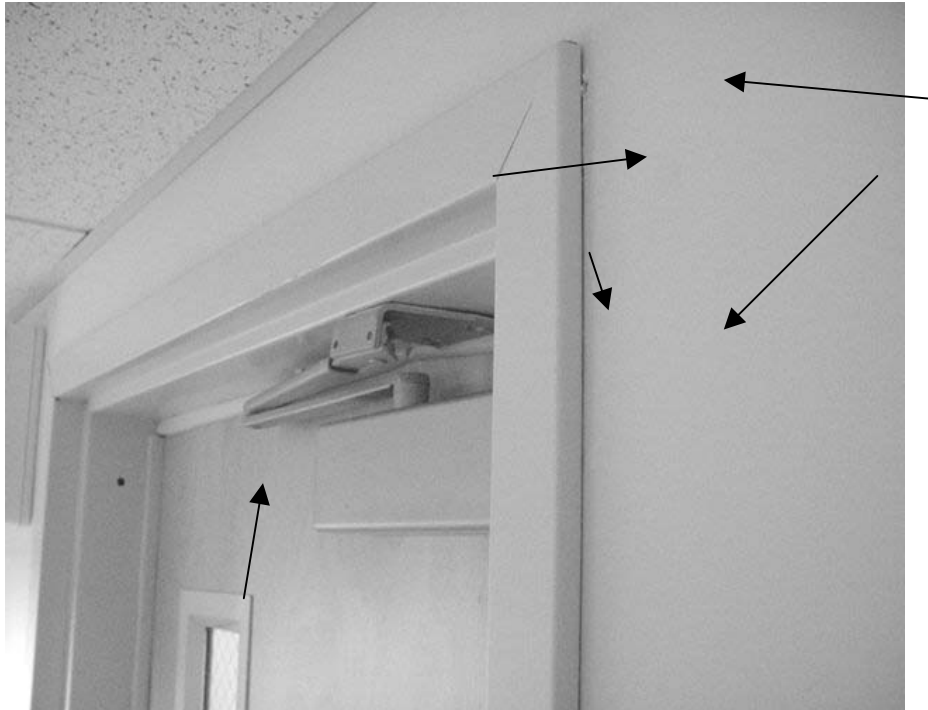
Picture 2

Arrows Indicate Doorframe/Wallboard Joints and Doorframe Seams That Need Be Rendered Airtight

9. Seal all stairwell doorframes/gypsum wallboard junctions with caulking.
10. Deactivate the first floor elevator foyer heater.

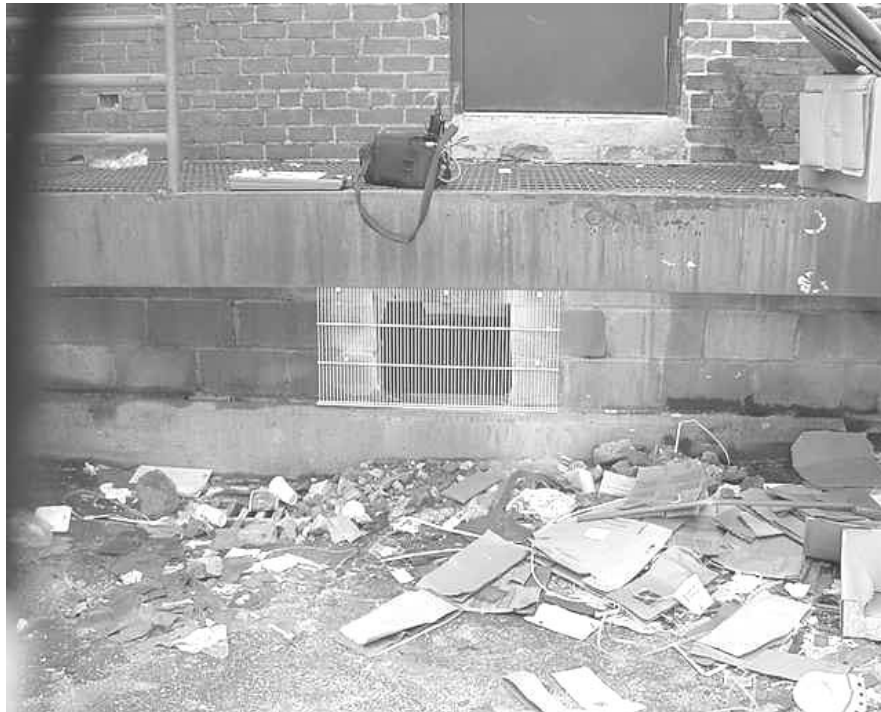
Picture 3

In addition to BEHA recommendations, a hole was also cut in the wall beneath the loading dock in an effort to provide odor ventilation/air pressure relief within the culvert (see Picture 3). After the implementation of these recommendations, BEHA staff could not detect culvert odors in

Pressure Relief Vent beneath Loading Dock of 17 Pleasant Street, Malden, MA

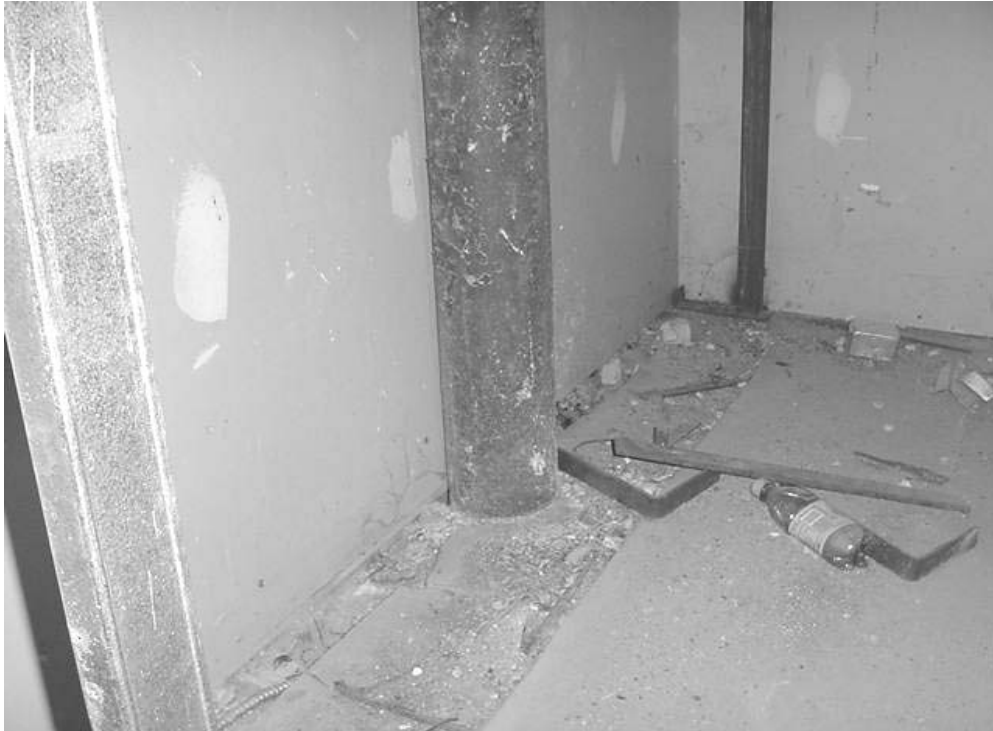
Picture 4

During the course of the April 10th assessment, Mr. Feeney was provided access to the barbershop that shares an interior wall with the first floor elevator lobby of 17 Pleasant Street. It appears that the renovation of this building resulted in the installation of a stairwell post that penetrates through the original flooring (see Picture 4). There appears to be several layers of floor in this wall space. Air movement was noted around the stairwell support post, which may indicate another odor pathway from the culvert (see Figure 1). If any space exists between the layer of flooring culvert odors may be drawn into the elevator shaft through spaces around the first floor elevator door faceplate.

Stairwell Support Pillar Penetrating Flooring of Old Barbershop
